REPAIR OF A FRACTURED PLASTRON IN A GREEN TURTLE (*CHELONIA MYDAS*)

Mirjam R. Hampel¹, David Robinson², Warren Baverstock² and Kevin Hyland³

¹Al Wasl Veterinary Clinic, Dubai, ²National Marine Aquarium, Dubai, ³Wildlife Protection Office, Dubai

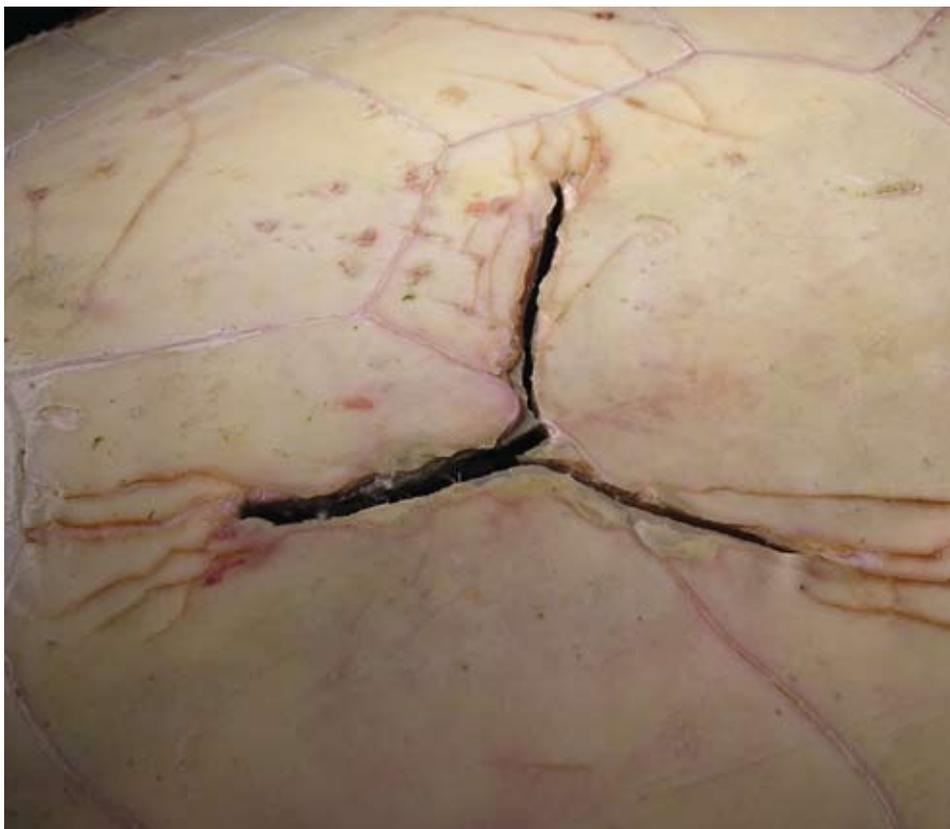
On 12th March 2008 a 30kg sub-adult Green turtle was found floating off 'Palm Jumeirah', Dubai. It exhibited strong positive buoyancy and had sustained a large plastron fracture as well as several injuries to the head and carapace (Fig 1). Wounds were washed with povidone iodine solution and rinsed with saline solution. Bone fragments were removed from the fracture site and the edges debrided.

Three fracture lines, in excess of 10cm length were present in the plastron, radiating from a central plastron deficit. The plastron moved freely at the fracture site with the weight and movement of the turtle. In order to immobilise the fracture screws were placed each side of the fracture. The screws used were sterile 12 mm self-tapping 316-grade stainless screws. A 2 mm pilot hole was drilled prior to fixing the screws. Whilst applying pressure to the plastron either side of the fracture, 30 G stainless steel wire was wound between the screws reducing the fracture gap. A single layer of sterilized fibreglass cloth, impregnated with freshly prepared, rapid polymerizing epoxy resin was used to cover the implants and fracture site (Fig 2). To prevent resin entering the deficit the fracture lines were packed with Dexpanthenol cream. When tack-dry, a second mix of resin was applied, this time including microfibre filler. This enabled the screw heads and entire repair to be planed smooth and prevent the repair fouling on any underwater structure.

Fig1. A massive triangle fracture of the plastron (caudal, right hypastron) (© Hampel).

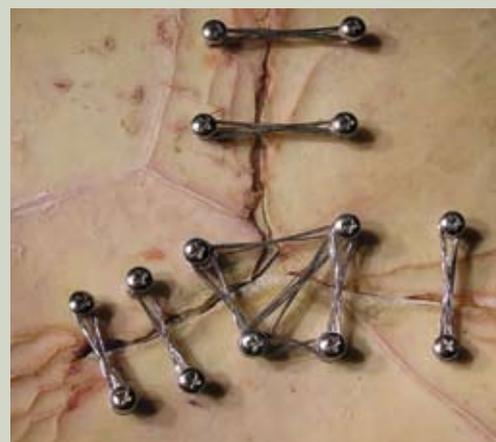
Fig2. 30 G stainless steel wire was wound between the screws reducing the fracture gap (© Hampel).

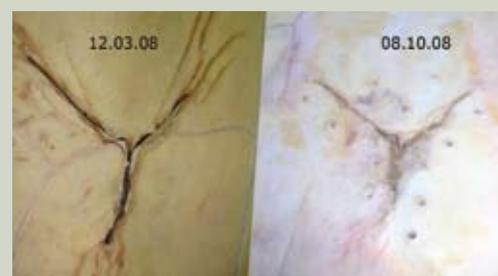
On the 8th October 2008 the repair-structure detached from the plastron as one piece, including the screws. Underneath the healing process was revealed (Fig 3). The large triangular plastron fracture was smaller, and the edges as well as the screw holes were covered with new healthy tissue. As the turtle is currently self-feeding aggressively on a diet of squid and mixed vegetables, and the positive buoyancy is resolved, the animal has been relocated to an open rehabilitation pre-release enclosure.

Fig3. Healing process 7 months after surgery (© Hampel).
